# Intel<sup>®</sup> Communications Chipset 8900 Series

Specification Update

*May 2014*

Document Number: 328000-005US

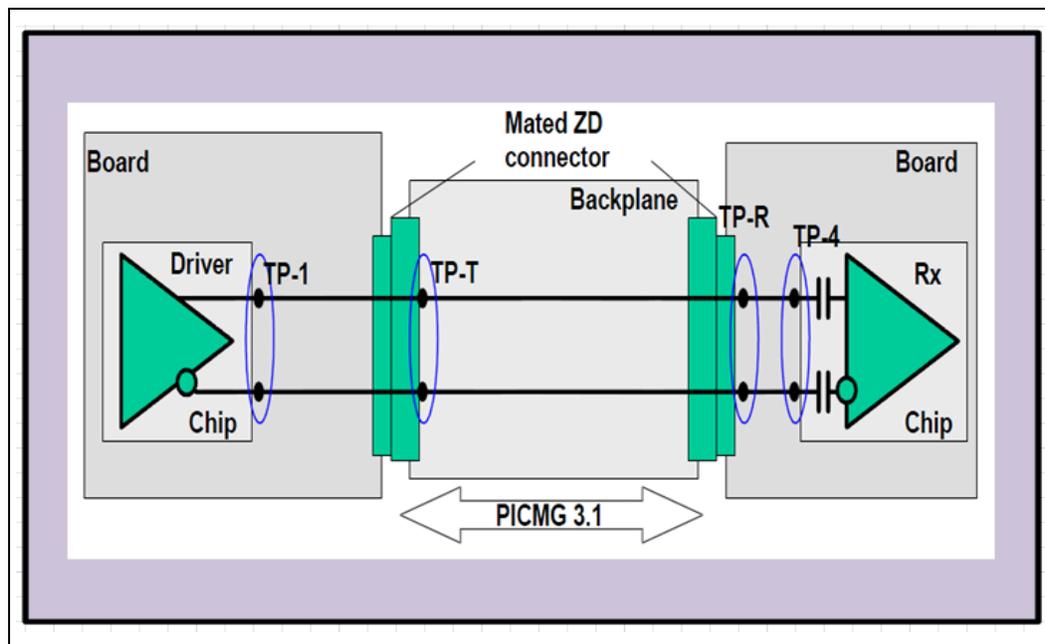
**Figure 2. 1000BASE-BX/FC-PI Transmitter Electrical Specifications**

**75. GbE: GbE Interface Transmit Voltage Level Specification Violation**

**Implication:** Although this is a specification violation, it does not affect the functional operation of the interface.

**Workaround:** Ensure that the signal routing length from TP-1 to TP-4 is greater than 10". Refer to *Intel® Communications Chipset 8900 Series Platform Design Guide (PDG)* for maximum routing length. (See [Figure 2.](#))
