PART NUMBER LDF-U3004RI		REV.
REV.	E.C.N. NUMBER AND REVISION COMMENTS	DATE

0.30" SINGLE DIGIT OVERFLOW DISPLAY,
635nm RED CHIPS, GRAY FACE, WHITE DIFFUSED SEGMENTS,
DIRECT DRIVE, RIGHT DECIMAL POINT.

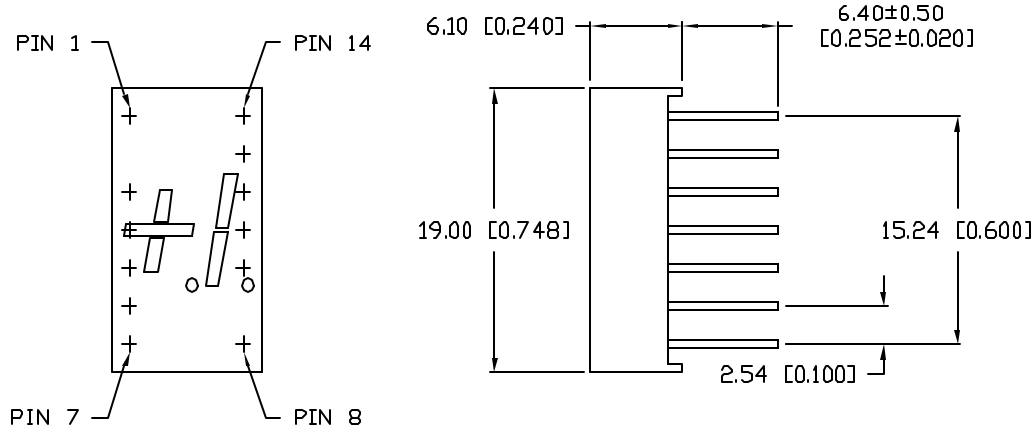
UNCONTROLLED DOCUMENT
*UNLESS OTHERWISE SPECIFIED TOLERANCE IS $\pm 0.25\text{mm}$ (± 0.010)

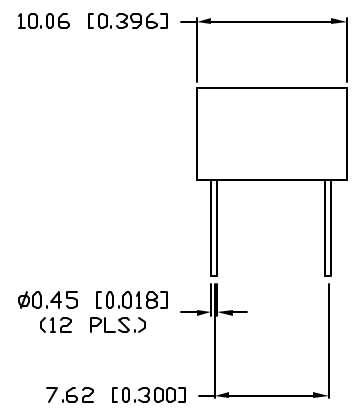
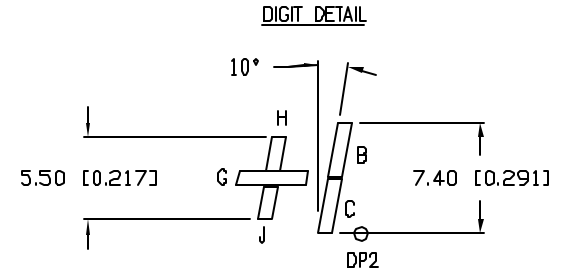
NO PIN: 2 AND 9
